## CLINICAL CASE

# The Use of OsteoCure™ Composite Plugs for Treating Bone Defects in the 1st MTPJ

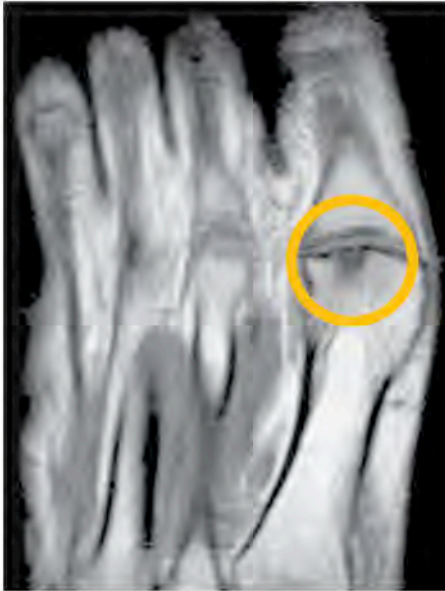
FIGURE 1: MRI

Conservative care including intra-articular steroid injections, physical therapy, NSAIDS's, off-loading pads and orthotics were unsuccessful in decreasing her symptoms. An MRI revealed moderately advanced change of osteoarthritis of the 1st MTPJ consisting of 2-3 mm foci of grade III-IV chondromalacia with subcortical bone marrow edema and sclerosis, as well as subchondromalacia cyst formation at the insertion of the capsule. Additionally, capsulitis was present and an intermetatarsal bursitis was found within the first intermetatarsal space. (Figure 1: MRI)

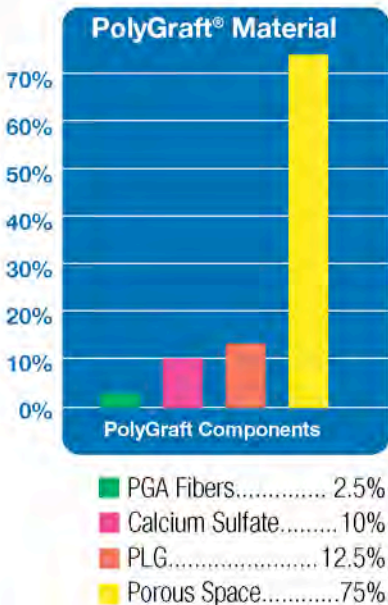
FIGURE 2: PolyGraft® Material

OsteoCure™ PolyGraft® composite plugs are 75% porous implants composed of a PLA and PGA co-polymer serving as a scaffold, and calcium sulfate for enhancing bone growth. (Figure 2: PolyGraft® Material) In the past, microfracture marrow stimulating techniques (MST) were utilized to violate the subchondral bone allowing marrow with stem cells to migrate to the surface for repair. Unfortunately, these open defects were exposed to the synovial fluid which could lead to cysts. The OsteoCure™ Plugs provide a protected, structural scaffold for the repair to occur.

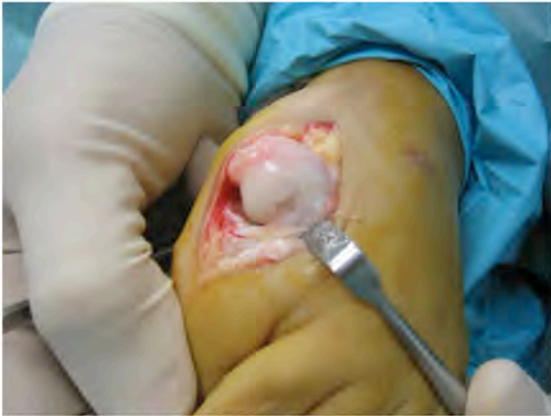
FIGURE 3: Defect

The patient was prepped and draped in the usual sterile manner after IV sedation and a Mayo Block. After elevation of the tourniquet, a standard dorsal medial incision was made followed by a capsulotomy. All hypertrophic bone and synovium were resected. The cartilage of the 1st MTPJ was inspected for damage which corresponds to that observed by preoperative MRI and X-ray. Adjacent to the cartilaginous defect was a “Zone” of discoloration which was softer than the surrounding cartilage. **(Figure 3: Defect)** The defect and “Zone” were measured with the sizer instrument to determine the exact diameter. The corresponding color-coded drill sleeve with matching cap was inserted into the defect taking care to ensure the drill sleeve is positioned perpendicular to the surface. **(Figure 4: Drill Sleeve)** Using a mallet, the drill sleeve was driven into the defect to a minimum depth of 5 - 8mm. The appropriate OsteoCure™ drill was then utilized to remove bone and tissue from the affected area. The corresponding OsteoCure™ Plug delivery device with the preloaded PolyGraft® implant material was measured for length, the excess was trimmed and the plug was press-fit into the defect. **(Figure 5: Delivery device)** Note: The implant, which is tamped smooth, must be flush with the surrounding tissue. **(Figure 6: Plug)** Range of motion is checked and closure performed.
